**Phase I
Environmental Site Assessment Report**

Sheffield Residence

9 Mead Street, Village of Sheffield
Sheffield Township, Warren County PA

February 9, 2007

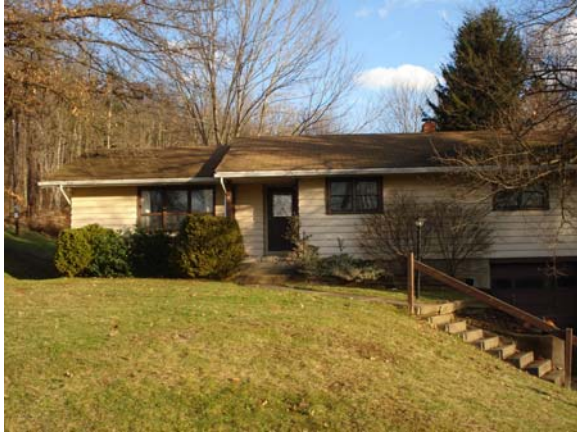
- The exterior of the dwelling was finished with painted wood siding.
- The roof was finished with three-tabbed asphalt shingles, which were installed in 1983.
- The paint around the exterior windows and garage door was observed to be peeling.
- The gutter and downspout system appeared to be intact.

Front of Home Looking East

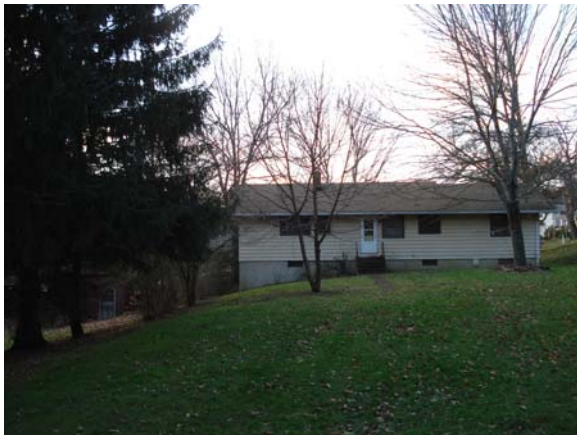
Back of Home Looking West

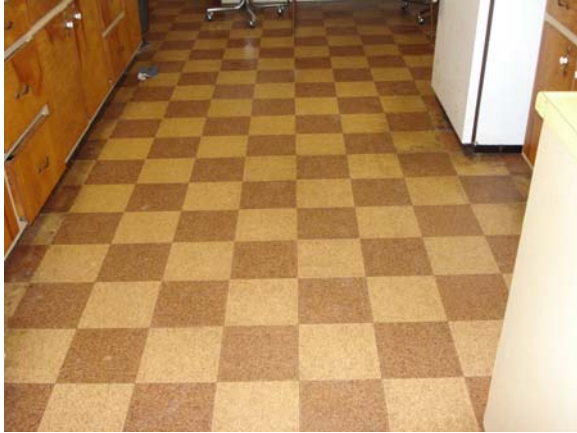
- The floors in the kitchen and bathroom areas were finished with 9" x 9" tiles; the remaining floor surfaces throughout the home were finished with hardwood.
- The walls were finished with painted drywall. The ceiling was finished with plaster.
- Approximately one inch of batted fiberglass insulation was observed covering the trusses in the attic.
- The tiles in the bathroom and kitchen area and the plaster ceiling appeared to be possible asbestos containing materials (ACM).

9" x 9" ACM Tiles in Bathroom

- The tiles in the front and back restrooms were found to be non-friable asbestos containing materials (ACM). The total area of the ACM was approximately 150 square feet.
- The duct tape insulation in the basement was found to be ACM with an approximate area of 60 linear feet.
- The estimated cost to remove the ACM from the home was \$1,500.00. This price would include the required monitoring, removal, and subsequent disposal into an EPA approved landfill, in accordance with Federal, State, and Local regulations.

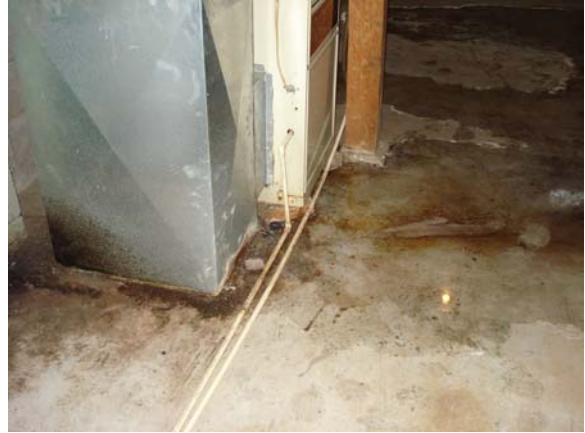
- The floor consisted of poured concrete. The walls forming the foundation of the home consisted of poured concrete. The ceiling was unfinished. The floor joists consisted of 2" x 10" wood members.
- The natural gas furnace and water heater were located on the south side of the room.
- The furnace condensate line was disconnected from the unit. Visible staining and standing water was observed on the floor.
- Light staining and possible visible mold was observed on the north, south, and east walls. The staining extended approximately four feet above the floor surface, along each wall.

Furnace Condensate Line Leak in
Basement

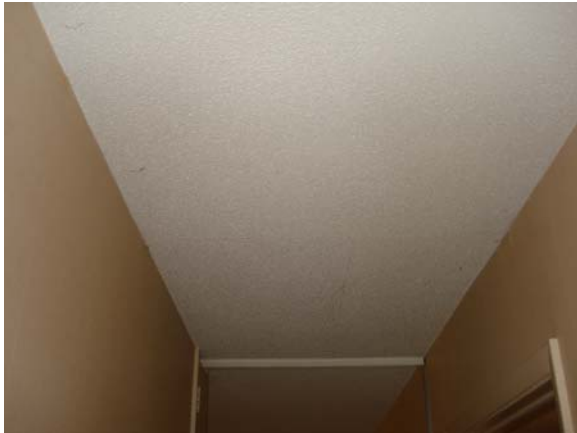
Non-ACM Plaster Ceiling

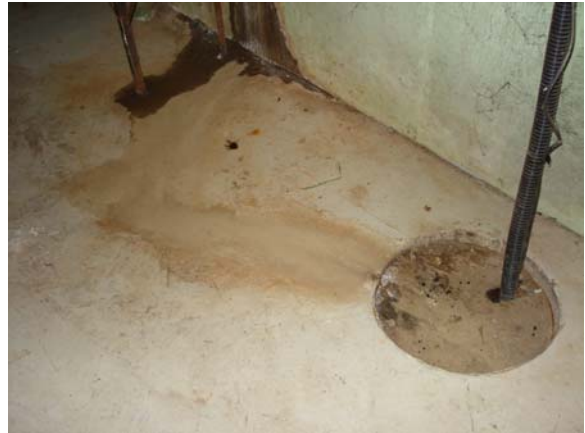
Light Water Stains on Floor Near Sump
Pump
